WAIKATO RIVER HEALTH AND WELLBEING – AN ANALYSIS OF TRENDS FOR SELECTED INDICATORS

Report Summary

This report on the Waikato River was prepared by NIWA for the Waikato River Authority's Five-Year Report to the Crown and River Iwi. The report provides an interim assessment of a subset of Report Card indicators.

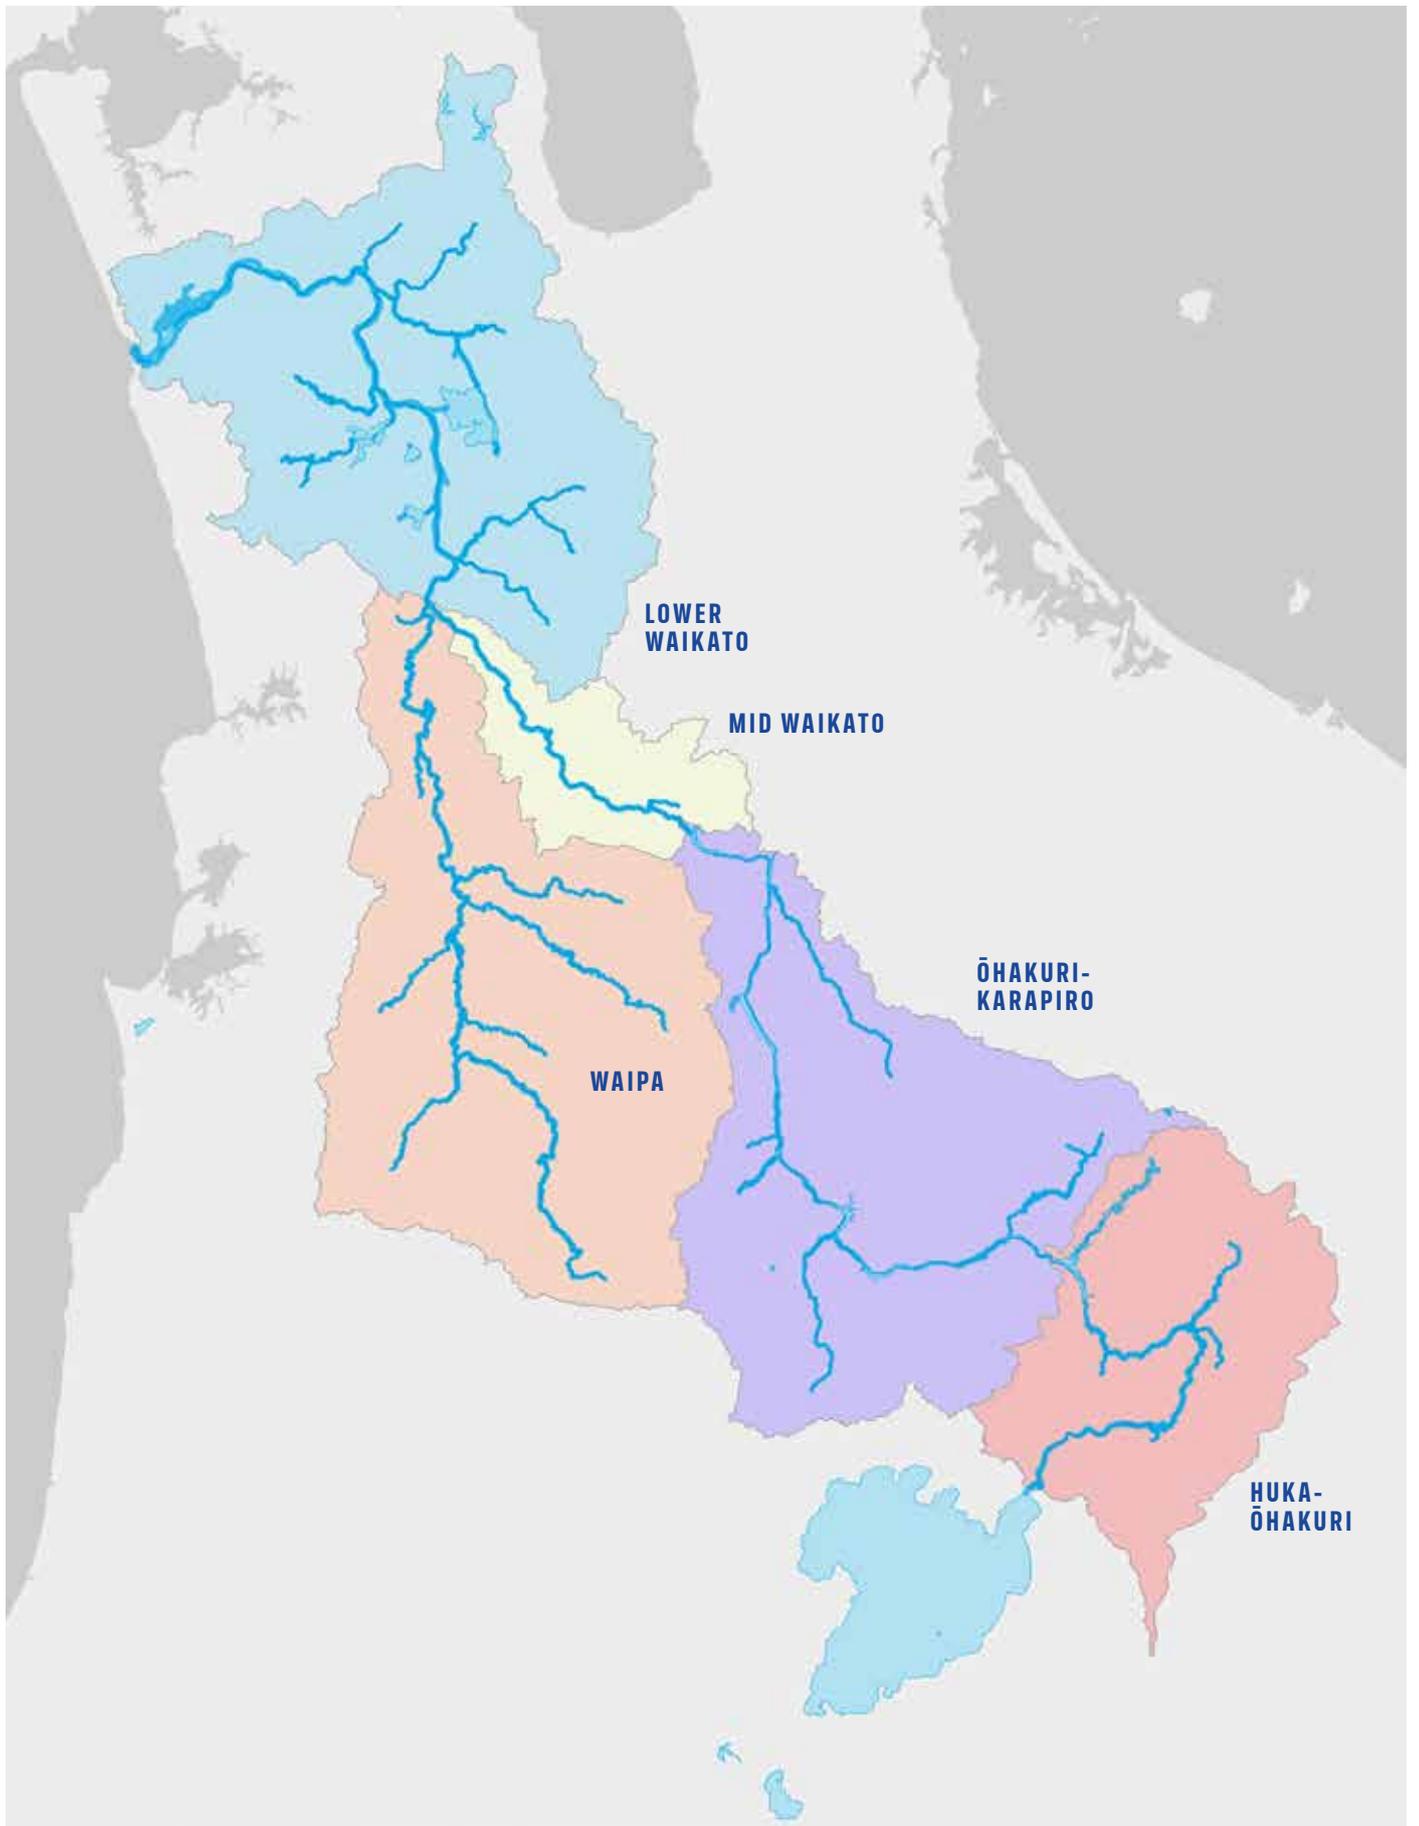
The Waikato-Waipā River catchment showing the five zones used to collate the results of the trends analysis.

To help communicate the spatial variability in the results the trends data analyses were grouped into five zones and 10 Report Card Units (RCUs) covering the Waikato River mainstem and tributaries (see map on page 5):

1. Huka to Ōhakuri – Mainstem (OW), tributaries (OWT)
2. Ōhakuri to Karāpiro – Mainstem (KW), tributaries (KWT)
3. Waipā – Mainstem (Wp), tributaries (WpT)
4. Mid Waikato (Karāpiro to Ngāruawāhia) – Mainstem (MW), tributaries (MWT)
5. Lower Waikato (Ngāruawāhia to Te Puāha) – Mainstem (LW), tributaries (LWT).

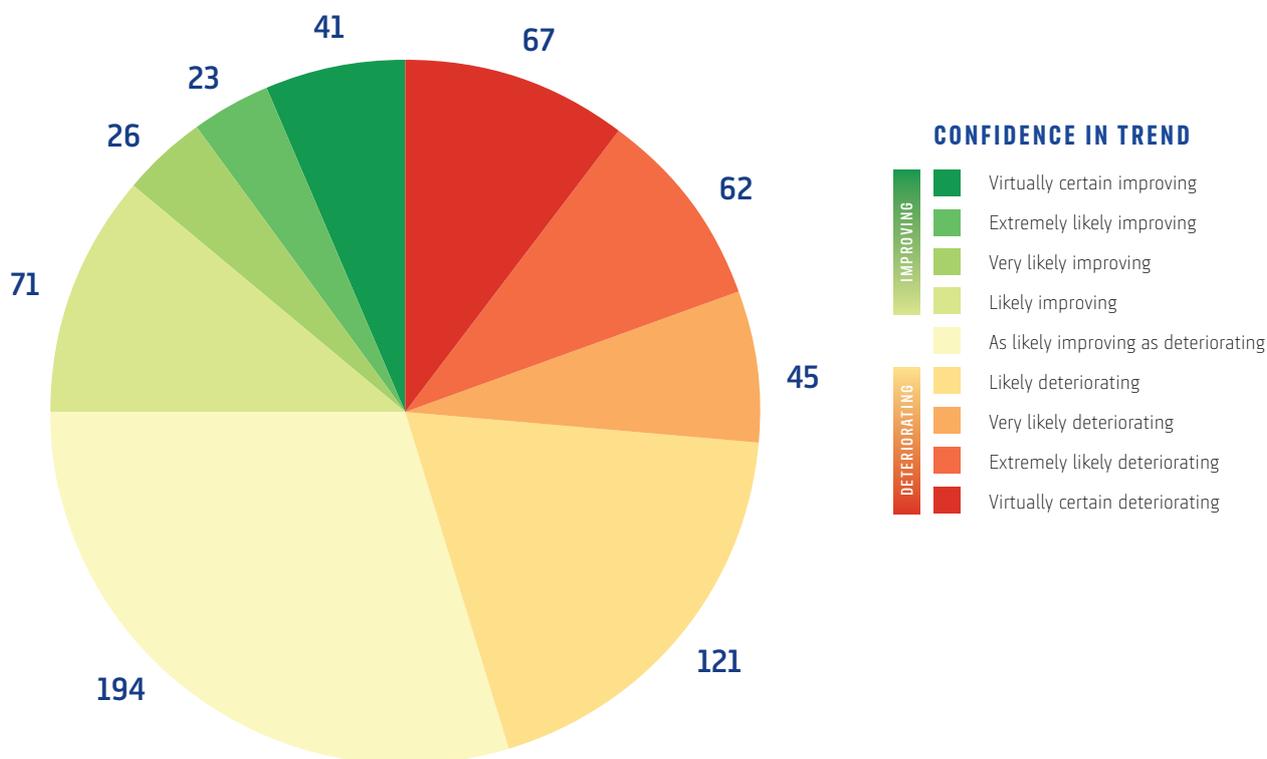
To provide a high-level summary of trends in the Waikato River and its tributaries we combined the results of the analyses for all 20 indicators into a pie graph.

650 trends were identified from a combination of indicators and sites over the 10-year period.

- 25% (161 of 650) of the trends were improving trends.
- 45% (295 of 650) were deteriorating trends.
- 30% (194 of 650) were as likely improving as deteriorating trends.

How to read the pie chart

The pie graph allows data to be presented in a circular manner where each piece of the pie represents the proportional fraction of the whole. In this report the site trends for each confidence category are tallied and then displayed as a proportion of the total number of sites showing trends for that indicator. The colour of the segments indicates the confidence that the trend is improving or deteriorating, with the number of sites in each category noted on the outside of the pie.

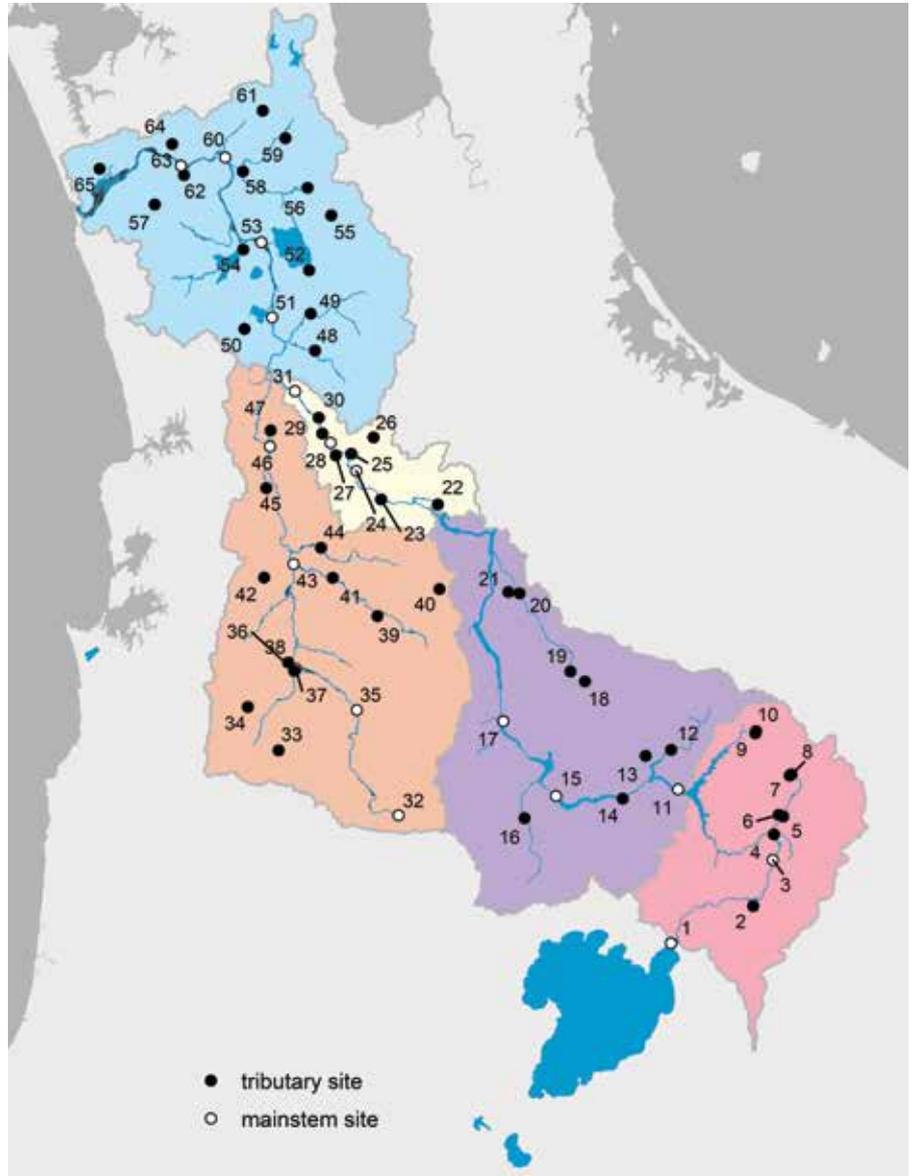
Monitoring site locations

Sixty-two Water Quality Monitoring sites were utilised to assess the trends for the nine water quality indicators. However, due to data processing restrictions the number of sites used varied between each indicators (refer to page 17 of the full report for more information on the data processing).

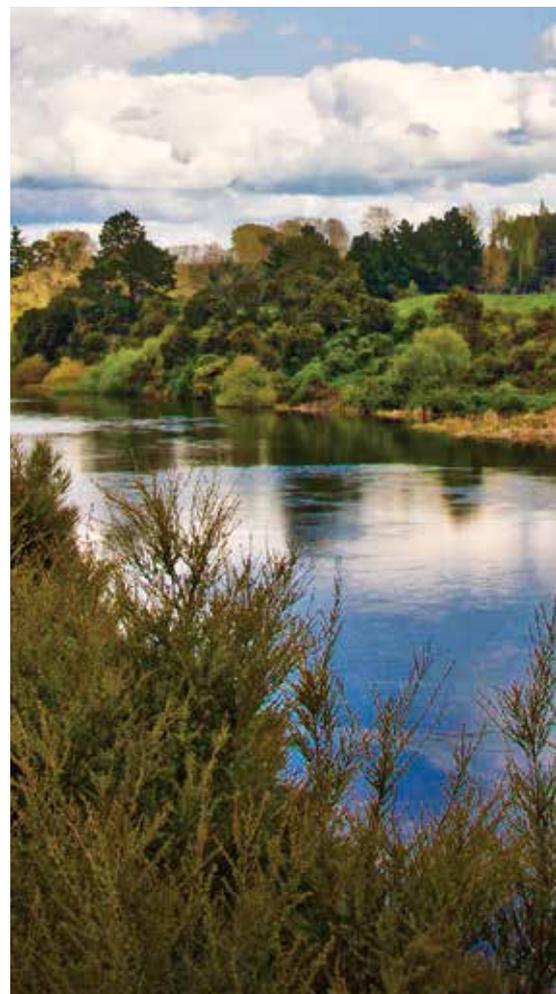
Water quality indicators were dominated by deteriorating trends across all RCUs except Huka to Ōhakuri mainstem, Karāpiro to Ngāruawāhia tributaries and Ngāruawāhia to Te Puāha mainstem.

Summary of the nine water quality indicators presented by Report Card Unit (RCU) over a 10-year period from 2010 to 2019.

The number of sites used in these assessments varied between indicators.

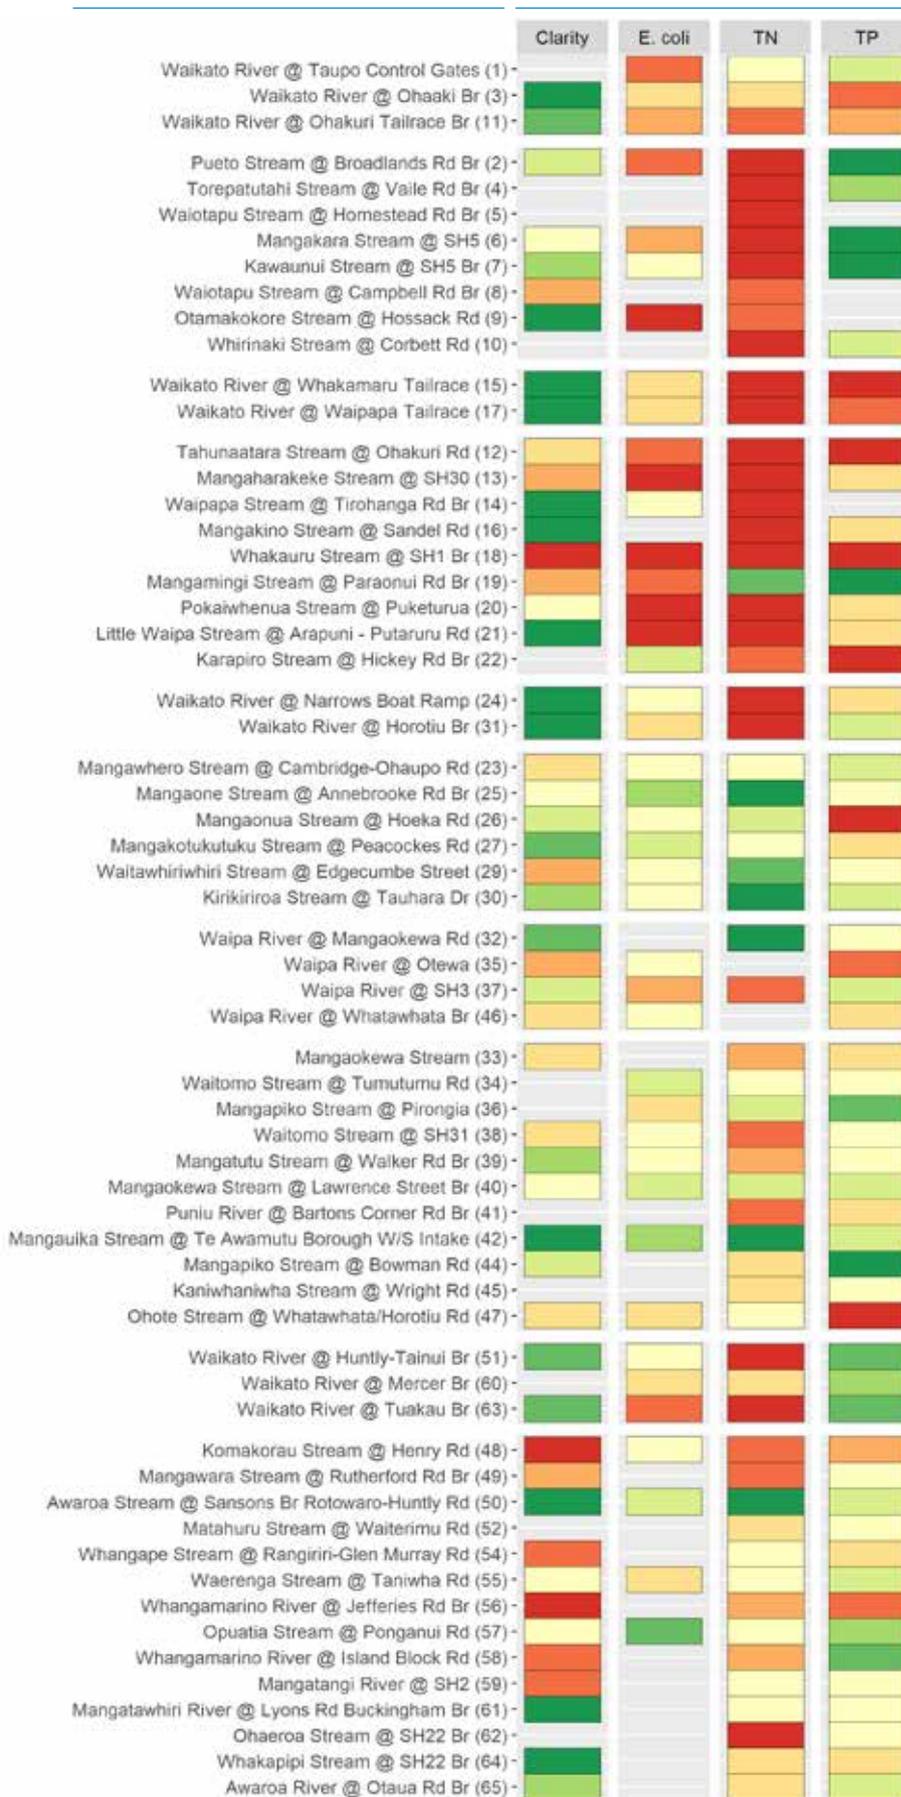
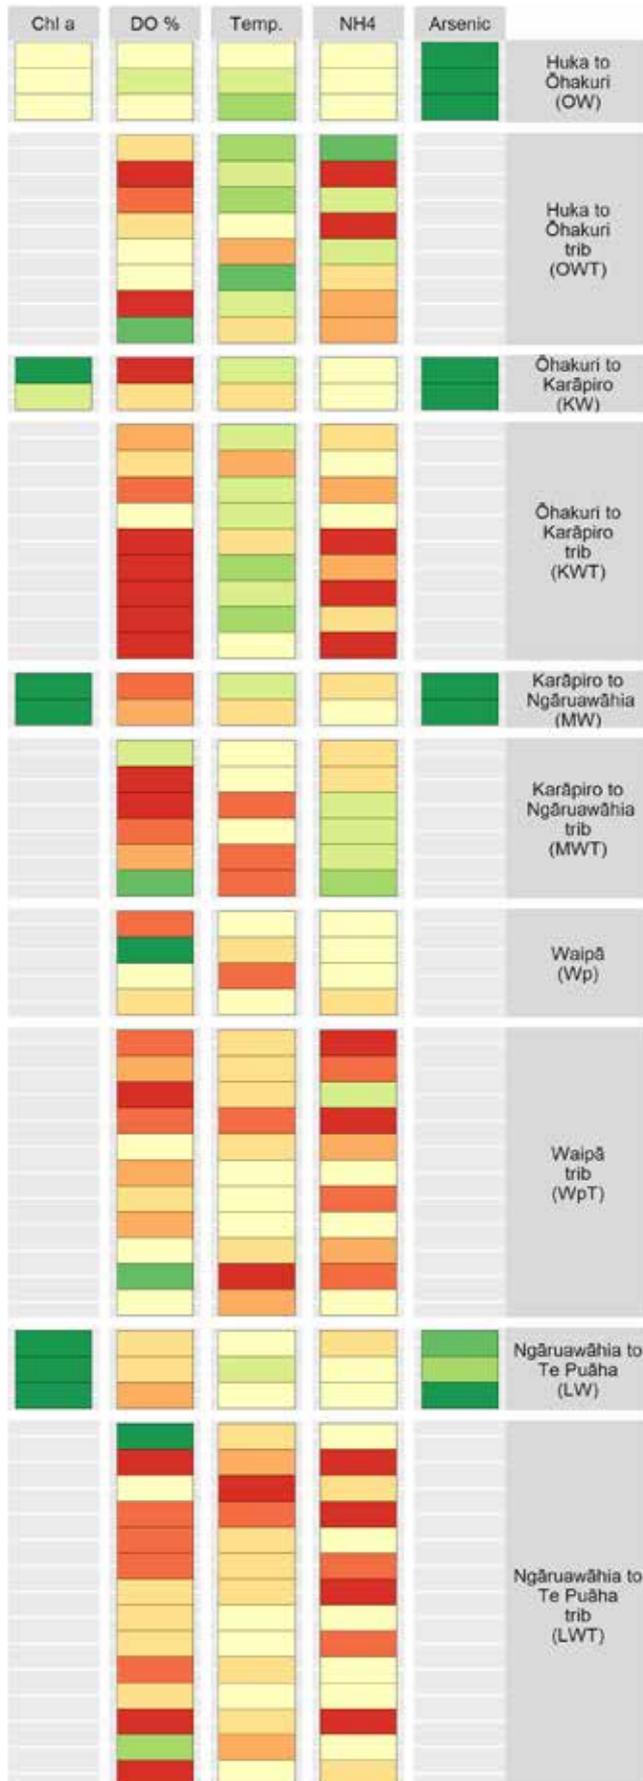
This graphic displays all 416 water quality trends that were identified for the 2010-2019 time period.

Heatmaps have a panel for each RCU/indicator combination, with individual sites listed longitudinally on the y-axis from upstream to downstream along the length of the Waikato River. Tributaries are ordered by where they join the river mainstem. Each cell represents a single site (site name listed down the left y-axis). The colour of each cell indicates the confidence in the trend.

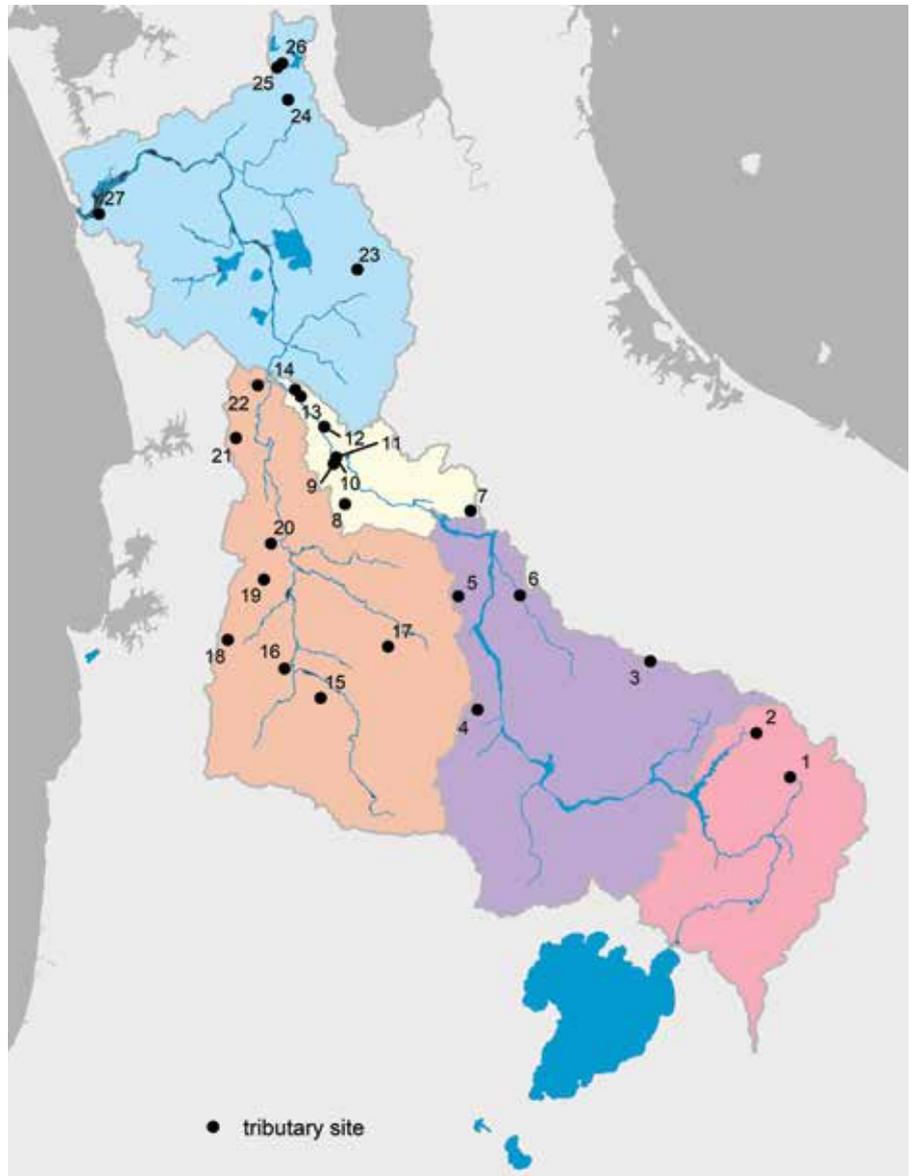
Monitoring site locations

Twenty-six Ecological Monitoring sites were utilised to assess the trends for the 11 ecological indicators. However, due to data processing restrictions the number of sites used varied between each indicators (refer to page 17 of the full report for more information on the data processing).

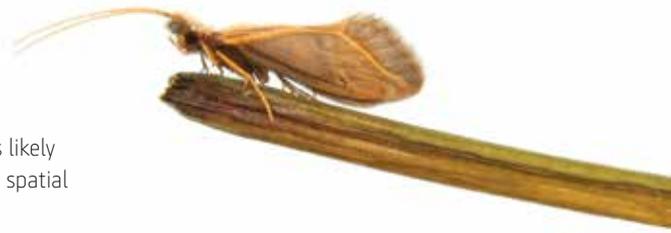
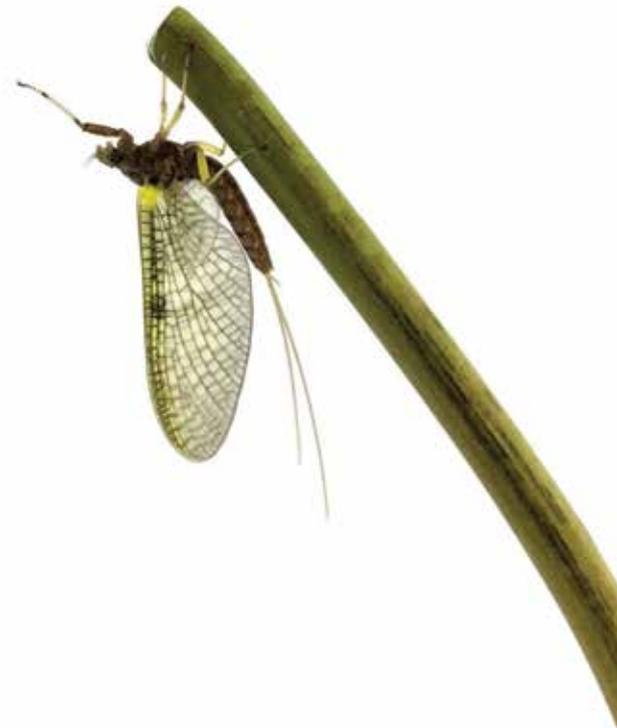
Ecological indicators were dominated by deteriorating or as likely deteriorating as improving trends across all RCUs except Karāpiro to Ngāruawāhia tributaries.

Summary of ecological indicators presented by Report Card Unit (RCU) over a 10-year period from 2010 to 2019.

The number of sites used in these assessments varied between indicators.

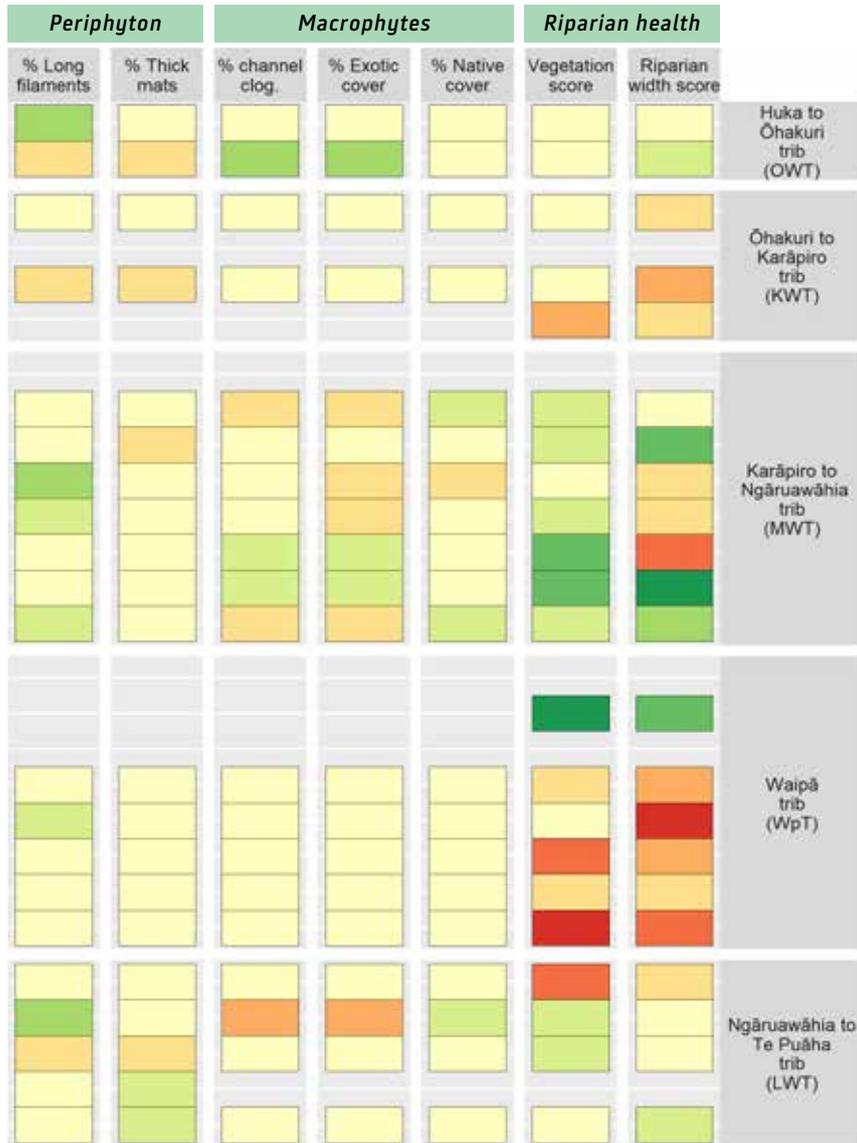
This graphic displays all 234 ecological trends that were identified for the 2010-2019 time period.

Heatmaps have a panel for each RCU/indicator combination, with individual sites listed longitudinally on the y-axis from upstream to downstream along the length of the Waikato River. Tributaries are ordered by where they join the river mainstem. Each cell represents a single site (site name listed down the left y-axis).
